Manhole Inspection Summary

Manhole # S27K__027MH

Insp Date: **6/3/08 2:09 PM**

Location Address: **850 Ryan**

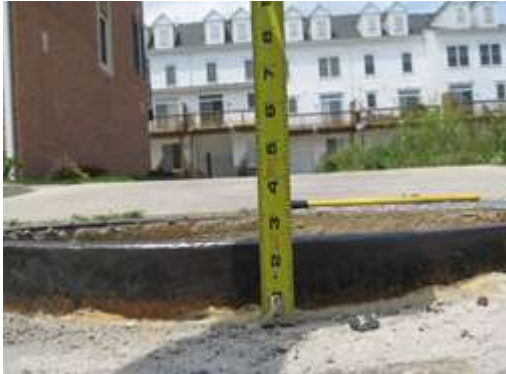
a/b

infiltration frame-lid connect

This will be addressed when final layer of asphalt is laid.

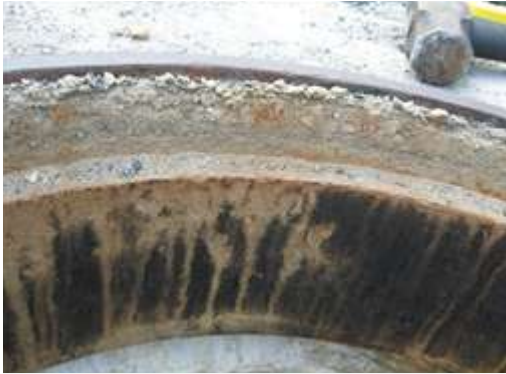
Defect 4

lid -frame infiltration

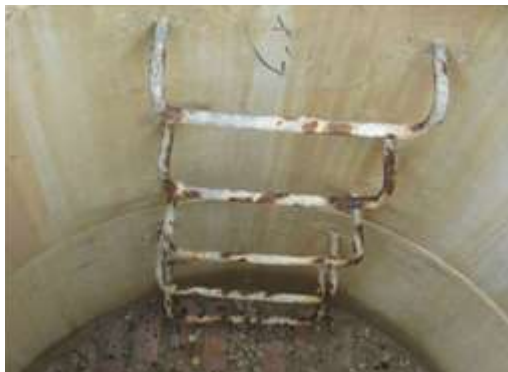
Defect 2

oxidized rungs

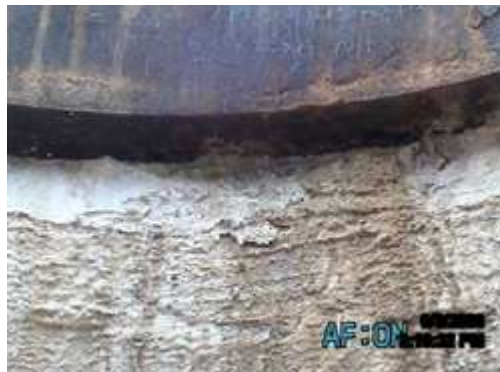
Defect 1

infiltration frame-chimney connect

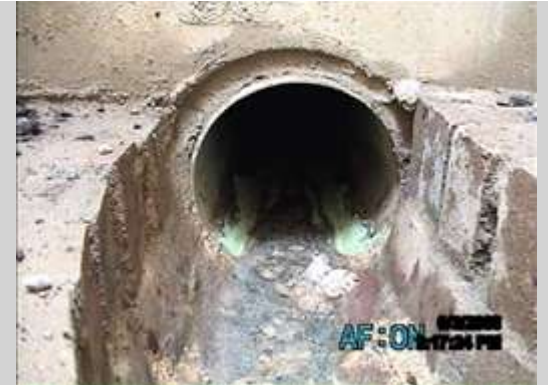
12 O'Clock Outflow

8 in. Circular Gravity Sewer
Pipe Out @ 12 O'Clock

Pipe Height: **8.4** (in.) Rod and Bar (Angled)
Pipe Material: **PVC** ☐ Pipe Lined
Invert Depth: **7.68** (ft.) Flow Characteristics: **None**
Deposits: ☒ None ☐ Mud ☐ Sludge ☐ Debris ☐ Grease
Silt Depth: **0** (in.) Deposits Extent:
Infiltration: **None** Pipe Seal Cond: **Sound**

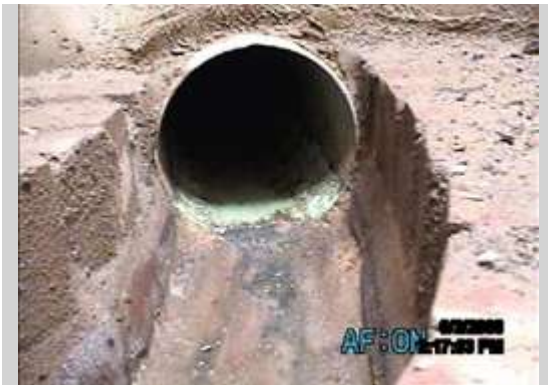
3 O'Clock Inflow

8 in. Circular Gravity Sewer
Pipe In @ 3 O'Clock

Pipe Height: **8.4** (in.) Rod and Bar (Angled)
Pipe Material: **PVC** ☐ Pipe Lined
Invert Depth: **7.59** (ft.) Flow Characteristics: **None**
Deposits: ☒ None ☐ Mud ☐ Sludge ☐ Debris ☐ Grease
Silt Depth: **0** (in.) Deposits Extent:
Infiltration: **None** Pipe Seal Cond: **Sound**
